March 25, 2022

RE: Stoney Acres Subdivision – Review of Drainage System  
Bay County, MI

## STONE ACRES SUBDIVISION - REVIEW OF DRAINAGE SYSTEM

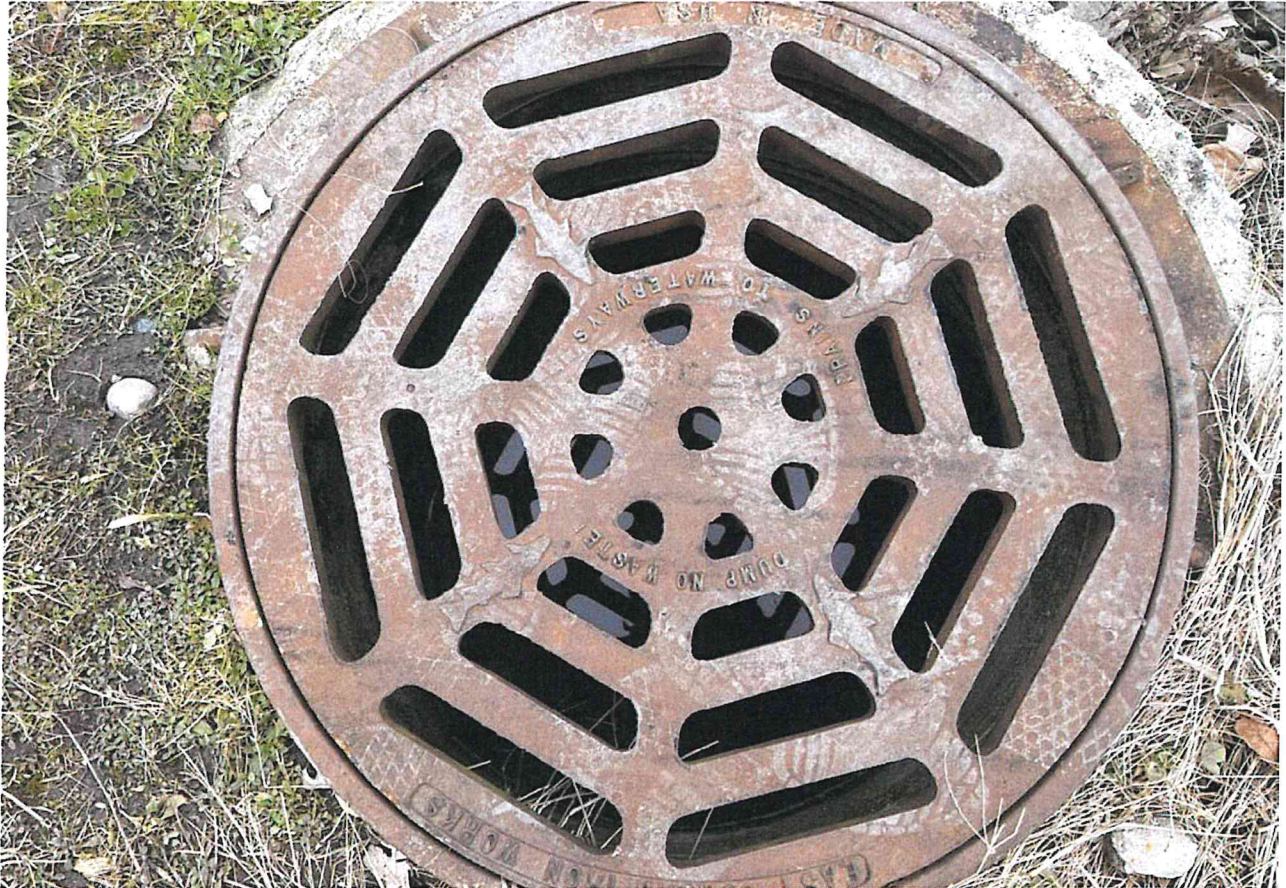
As described above, the detention basin and storm sewer holds approximately four (4) feet of water at all times. Due to this fact, the drainage structures and the storm sewer pipes were submerged at the time of inspection as expected. Because of the submerged nature of the storm sewer, it is not possible to visually see the condition of the existing storm sewer from the surface. In addition to inhibiting visual inspection

Standing water and submerged pipe in catch basin

Because we could not visually assess the condition of existing storm sewer, we are recommending having the sewer cleaned and video inspected (also referred to as televising) to ensure proper function and identify any deficiencies. To perform these tasks, the storm sewer will need to be dewatered by pumping the water out of the system.

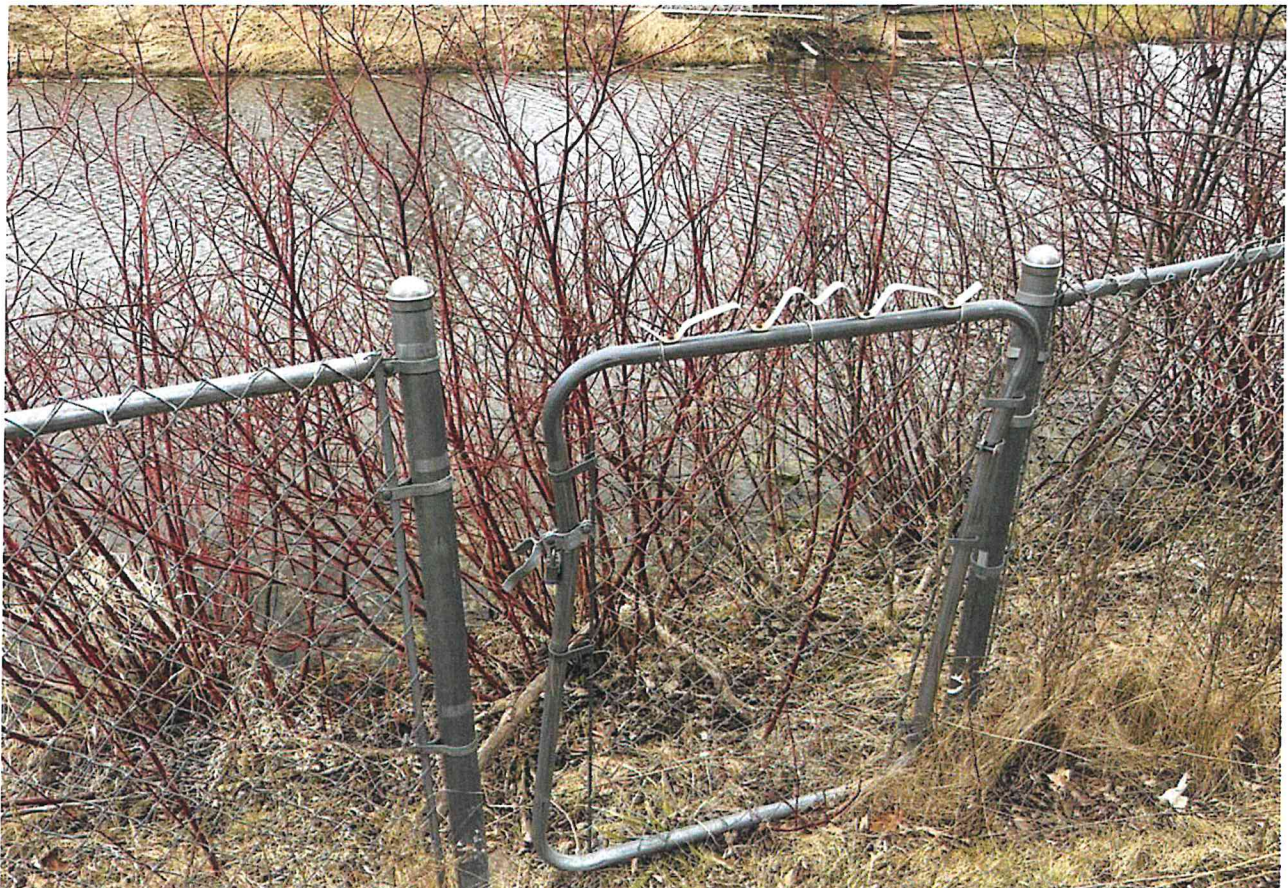
Damaged fence gate

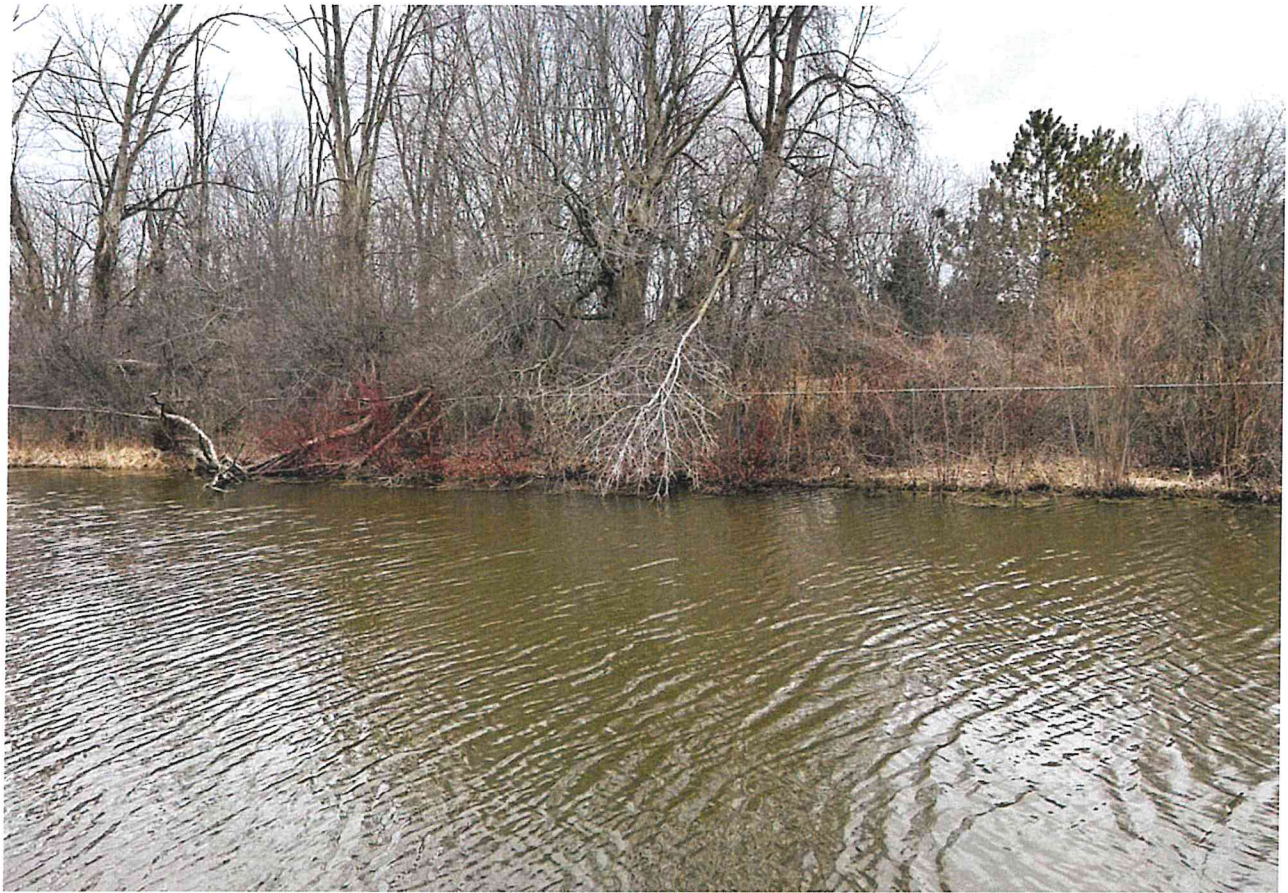
The Detention Basin appeared to be functioning properly, in regard to storing stormwater and releasing water to the storm sewer outlet, however there are several condition issues that were observed. Trees have fallen from the adjacent property into the basin. These fallen trees have also damaged the fence surrounding the basin at multiple locations. We recommend removing these trees and repairing the damaged portions of fence.

Fallen trees and damaged fence on north side of pond

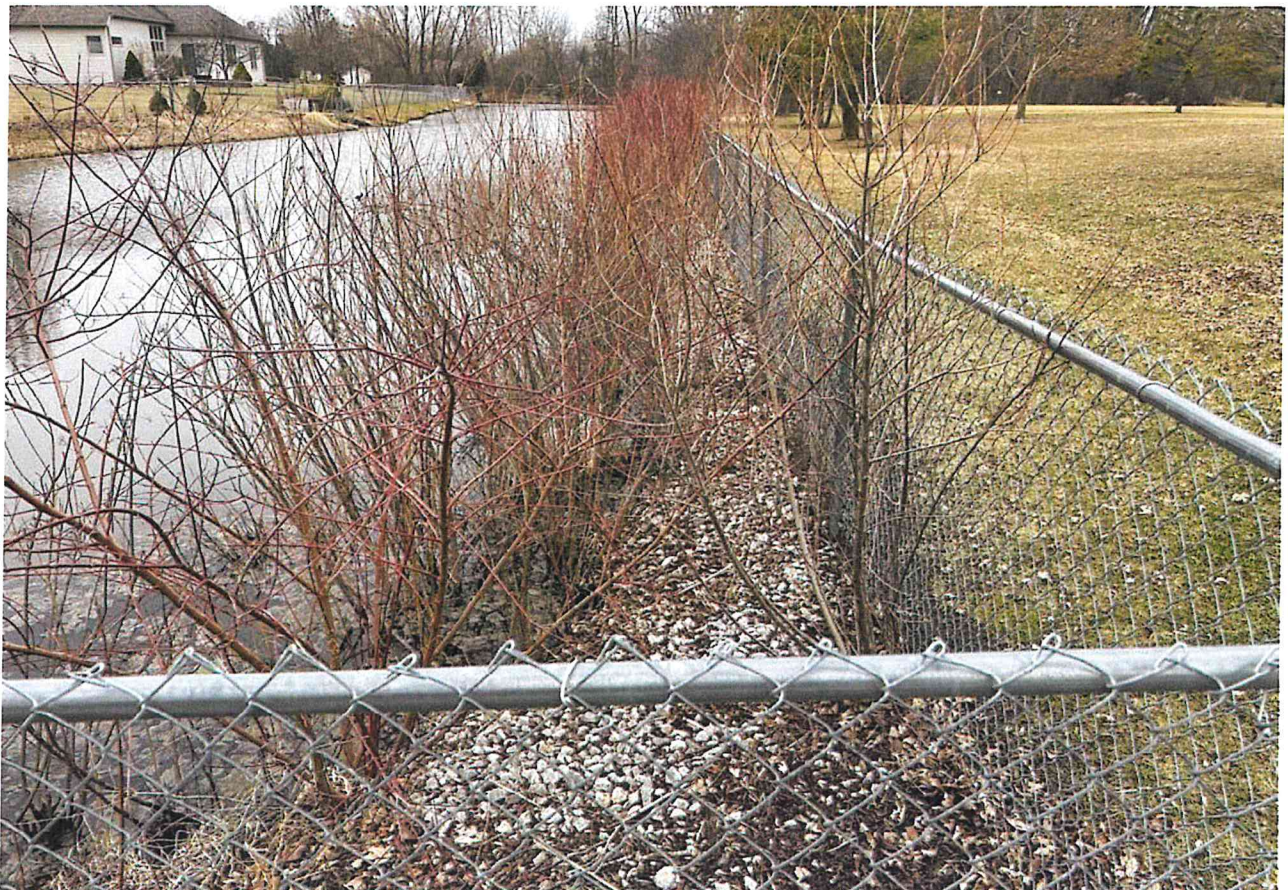
Due to the nature of being a wet detention basin, the slopes of the basin are saturated and unvegetated. These conditions appear to have led to slope stability concerns. The banks appear to be settling around the basin and sloughing into the detention basin forming steep slopes. We also observed what appeared to be several small pump houses near the detention pond indicating that some residents may be using the pond water for irrigation purposes. Rapidly and repeatedly drawing down the pond with pumps can encourage/accelerate the sloughing previously mentioned. We recommend against frequently having rapid drawdowns on the pond. Any drawdowns being performed should be gradual and solely for the purposes of maintenance. We are unclear as to what slope was used when constructing the basin as the 6 horizontal to 1 vertical slopes indicated on the plans will not physically fit in the footprint shown on the plans or occupied in the field.

North bank of pond

We recommend performing maintenance to prevent further erosion of the pond banks by placing riprap or other reinforcing measures and removing any accumulated sediment that may be obstructing the storm sewer outlet for the drainage system.

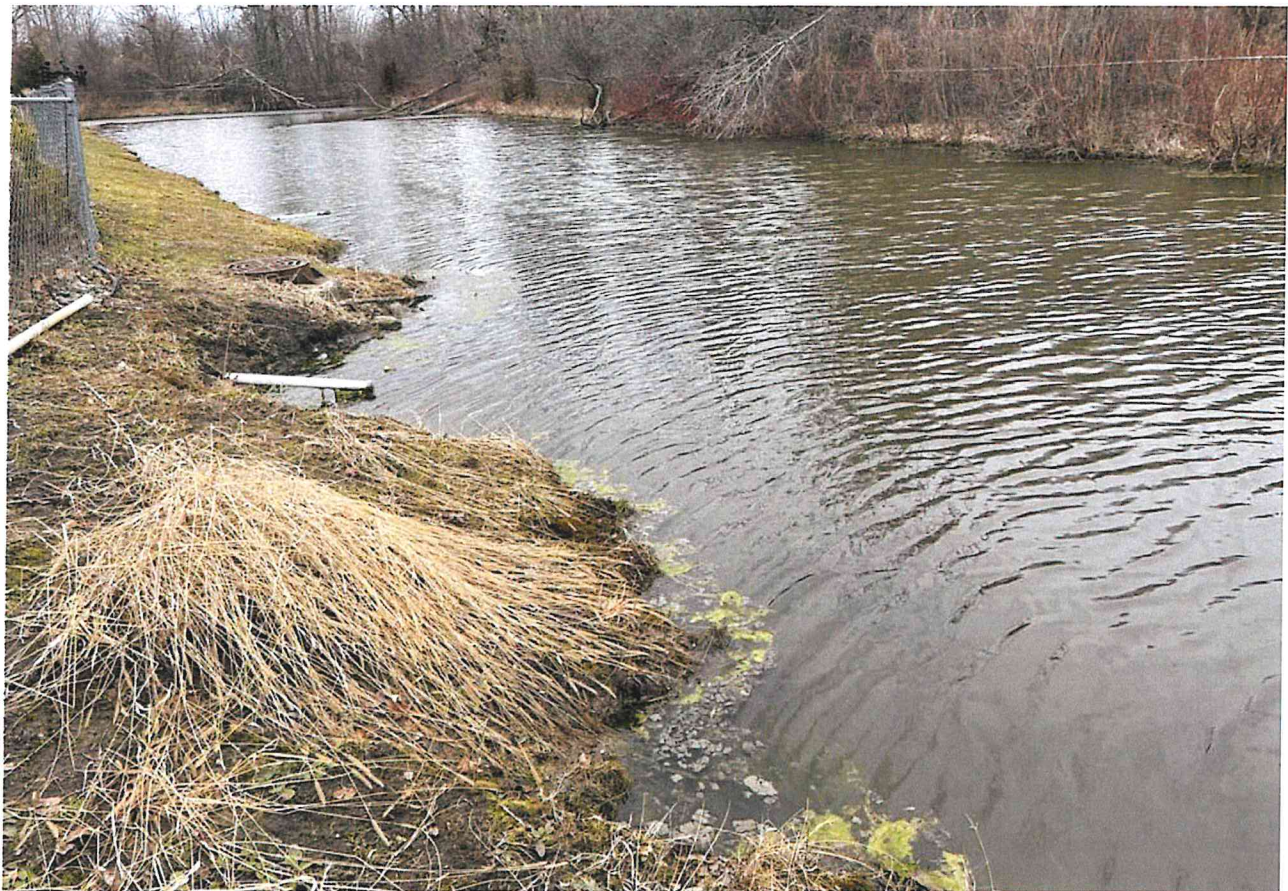
Erosion on south bank of detention pond

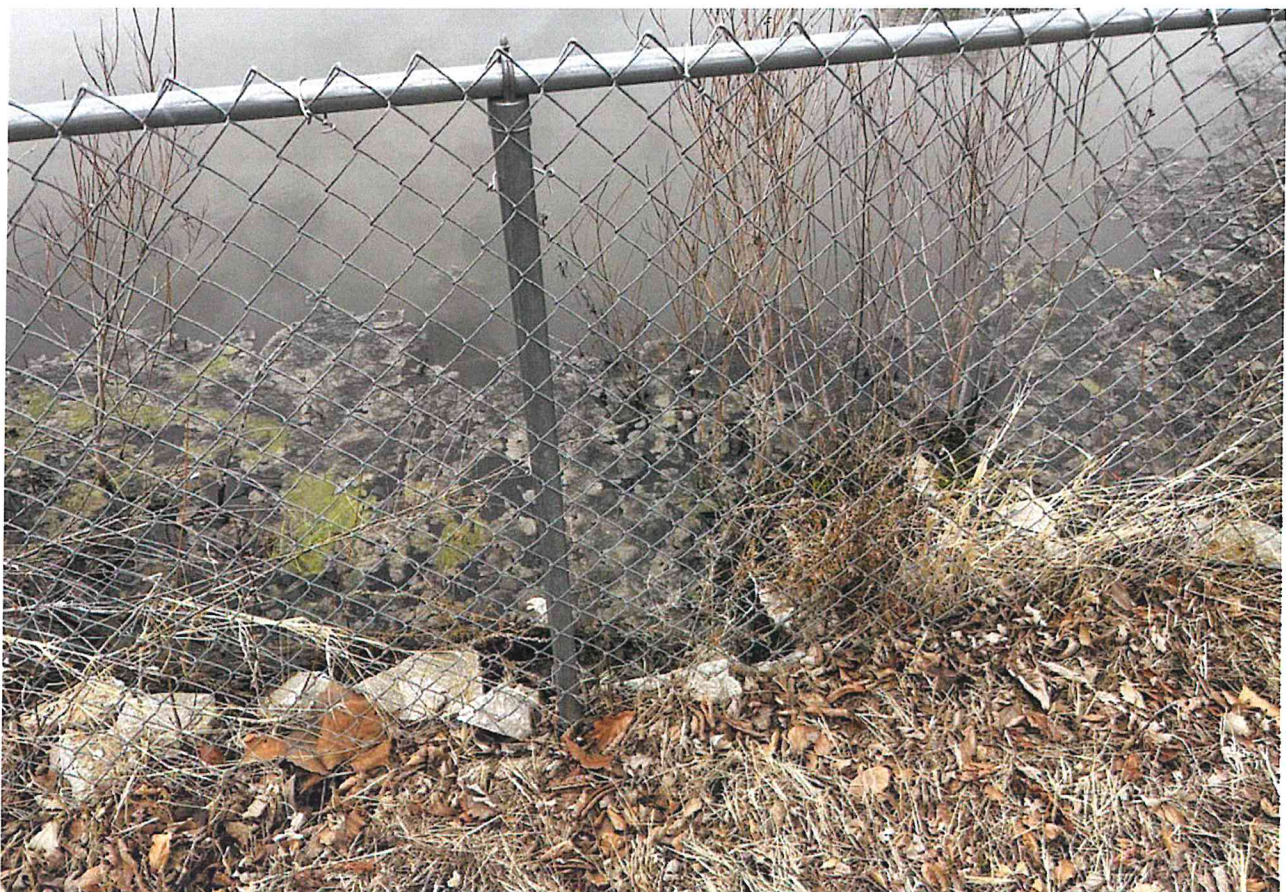
Eroded bank on east side of detention pond

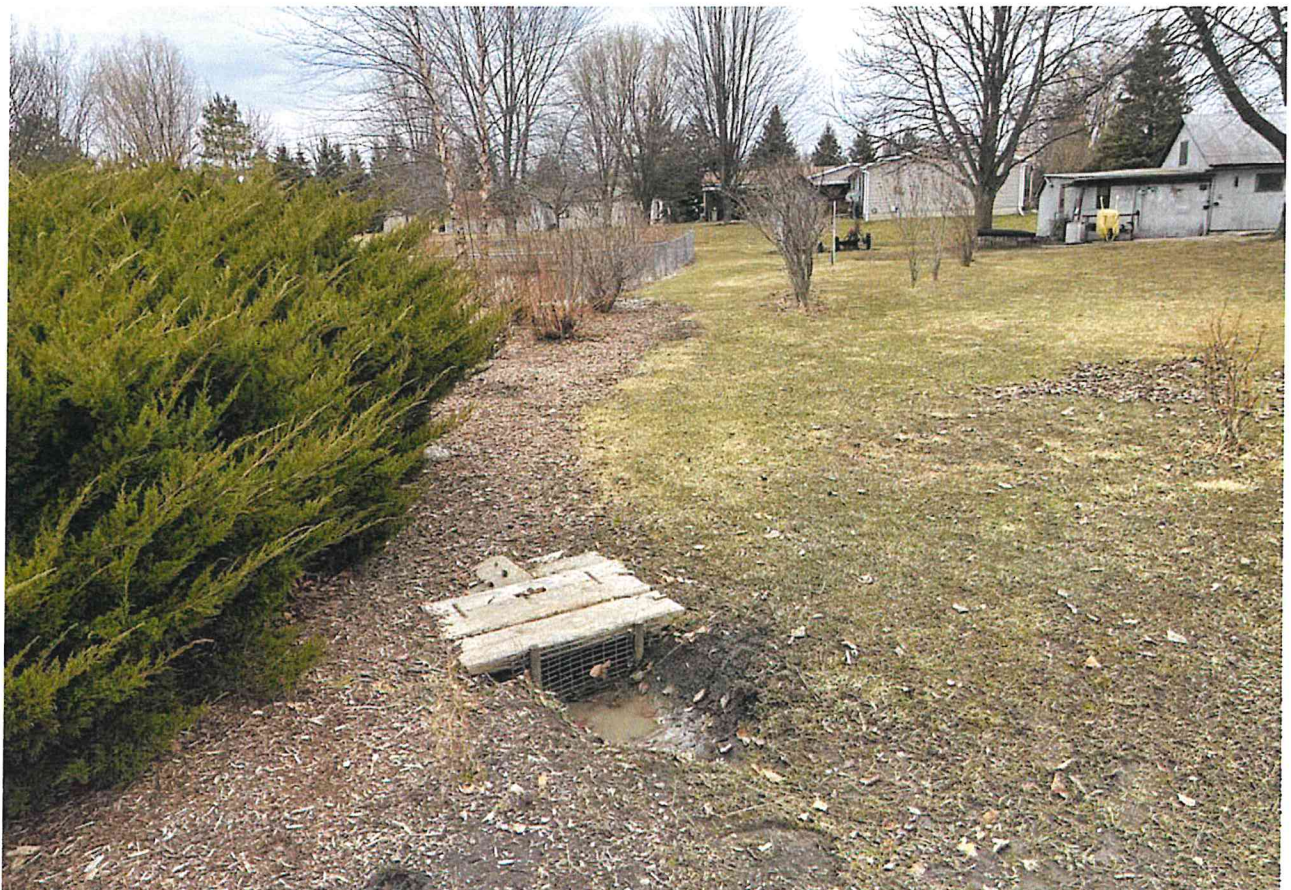
Based on the design plans, the minimum top of bank elevation around the detention basin was to be 596 feet with the proposed top of storage for the 100-year storm to be 595 feet. Based on review of 2016 elevation contour data available from the Bay County GIS, it appears that there are elevations on the north and east side of the detention basin that are between 1 foot to 1.5 feet below the proposed elevation of 596 feet. It is unclear if this is related to the original construction not following the plan or due to settling. Additionally, it was observed that many of the drainage patterns of the surrounding parcels outside of the subdivision are encouraging water to drain into the detention basin. Based on the design plans, it does not appear as if any non-subdivision drainage was accounted for in the basin design.

Storm water inlet to adjacent non-subdivision parcel

We recommend the ground elevations surrounding the pond be surveyed to verify the maximum allowable storm water storage elevation. The calculations performed for the design of the detention basin should also be reviewed to verify that proper volume in the detention basin exists for the additional storm water being contributed by the neighboring parcels.

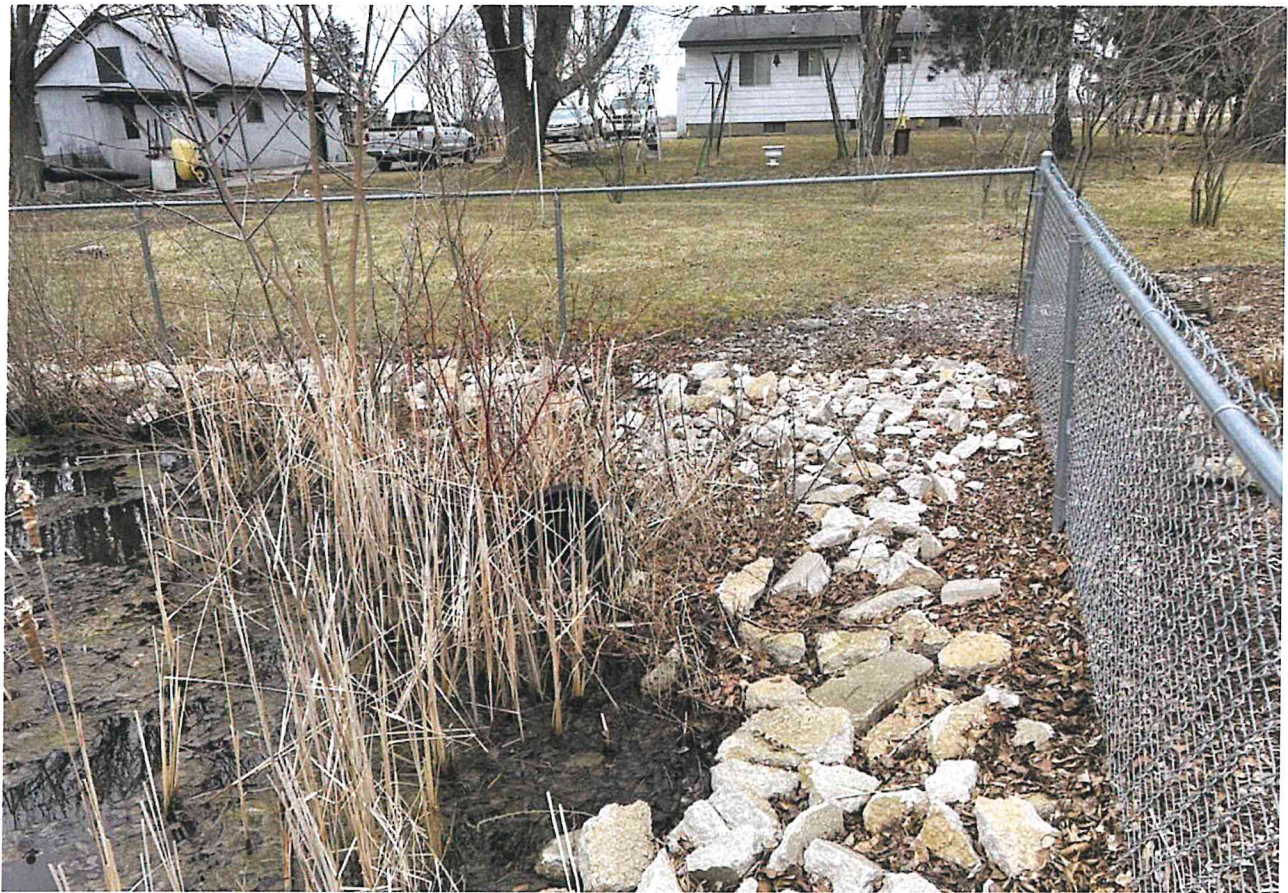
The last item reviewed was the outlet storm sewer of the detention basin that conveys storm water into the county drain. Storm sewer pipe for the outlet appeared to be in fair condition. It appeared as if there may have been some movement of the plastic storm sewer inlet at the pond. Based on the design plan this pipe was intended to be a reinforced concrete pipe sewer, which would have been more resistant to buoyancy forces and movement. Upward movement of this storm sewer inlet can affect the elevation at which the

Detention pond outlet

water level in the pond is maintained and the amount of stormwater storage available. We recommend surveying the elevation of the pipe and correcting any elevation issues that exist.

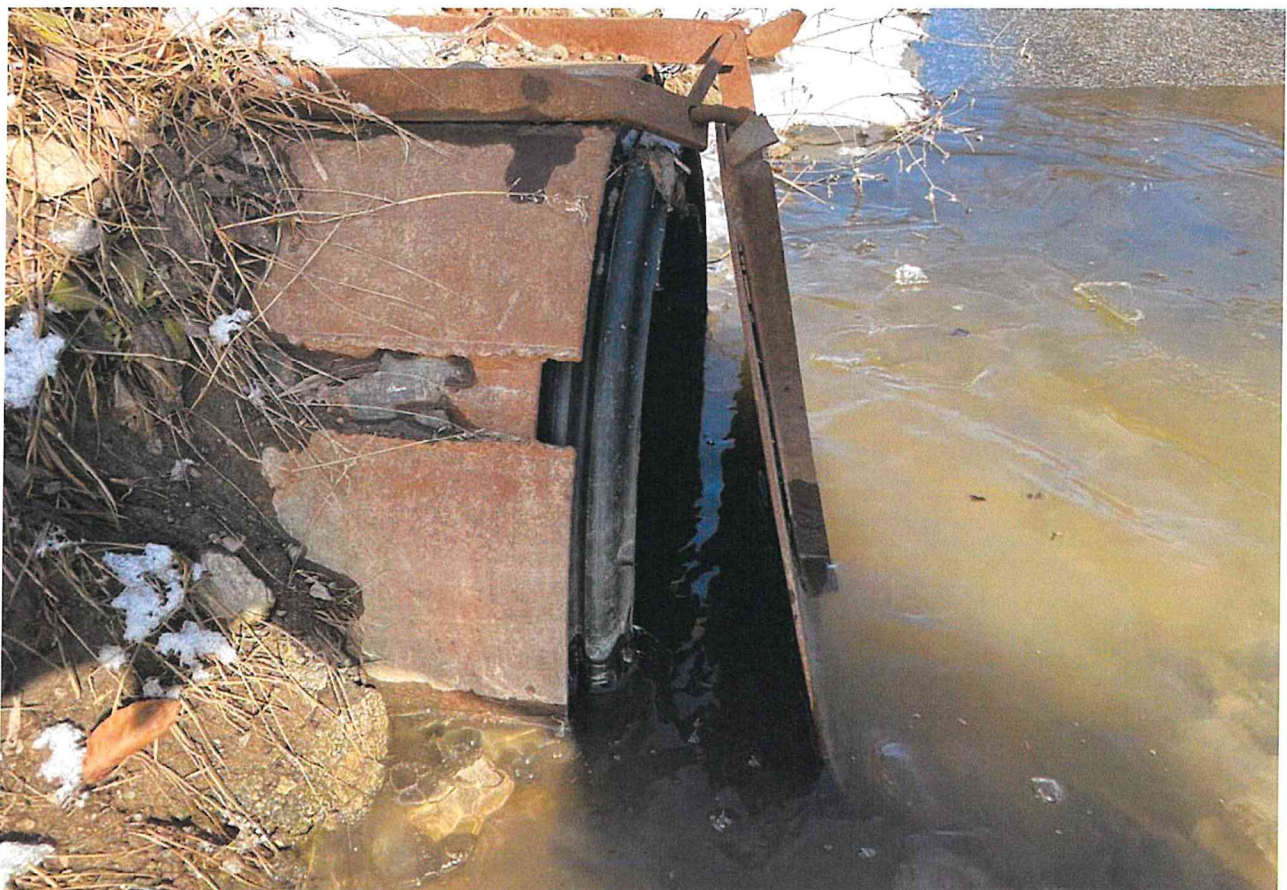
On the downstream end of the outlet storm sewer, the flap gate in the county drain is in very poor condition and is not functioning. The flap gate appeared to be a poorly fabricated flap gate by the contractor as opposed to an engineered, commercially available flap gate. The flap gate is very light weight and as a result has sustained severe damage. The bottom of the flap gate was also stuck open due to sediment in the drain bottom. If the sediment were removed, it is unclear if the flap gate would be able to operate correctly due to severe damage and low-quality construction. We recommend replacing the existing flap gate with a heavy duty commercially available flap gate mounted to a pre-cast concrete headwall.

Flap gate unable to close or open due to sediment and damage

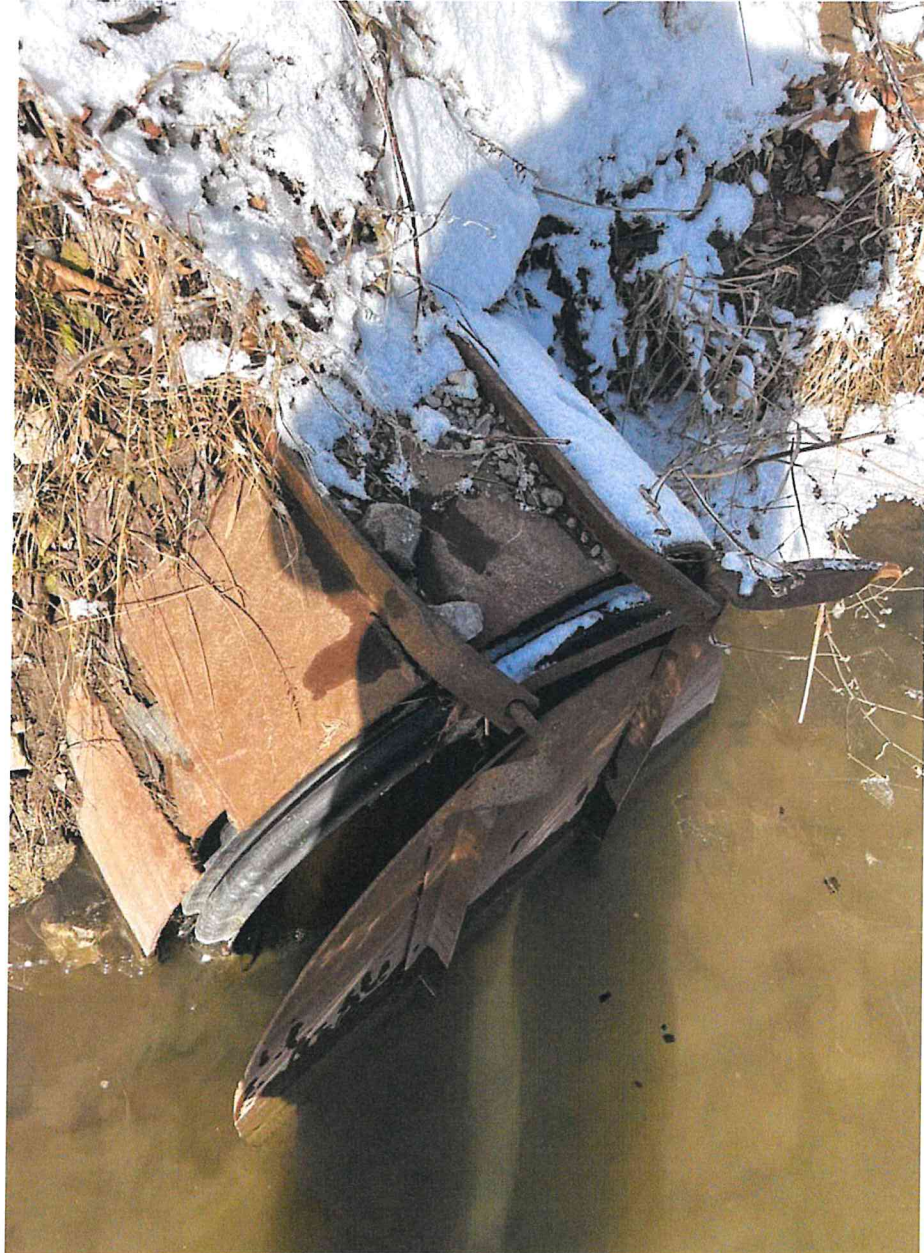
Damaged flap gate
